### Supplier Alert - Toyota and Lexus Vehicles:

March 24, 2023

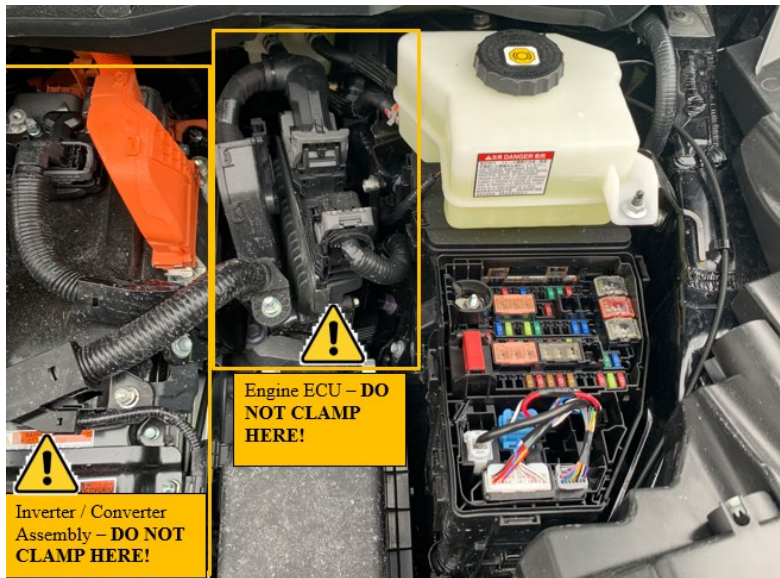
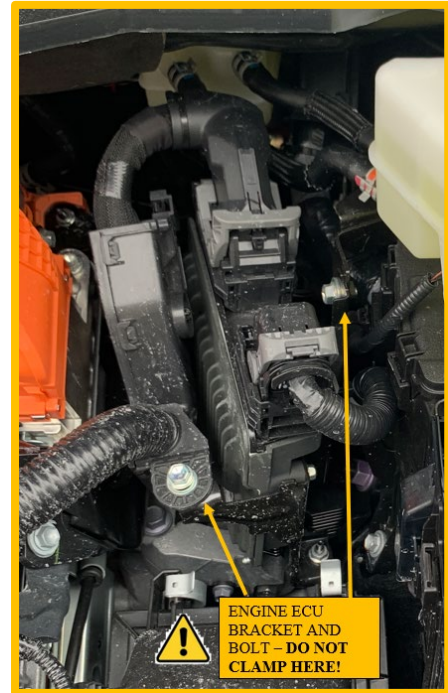
#### Sienna Hybrid example of incorrect negative connection points:

ASG has been alerted regarding damage claims related to Boost services performed on Toyota & Lexus vehicles with blown damaged Engine ECU (Electronic Control Unit). The Manufacturer has identified that damage may occur as a result of connecting the negative lead too close to the ECU (not reverse connection).

**DO NOT CLAMP ONTO ENGINE ECU/BRACKETS OR ONTO OTHER ELECTRICAL COMPONENTS**

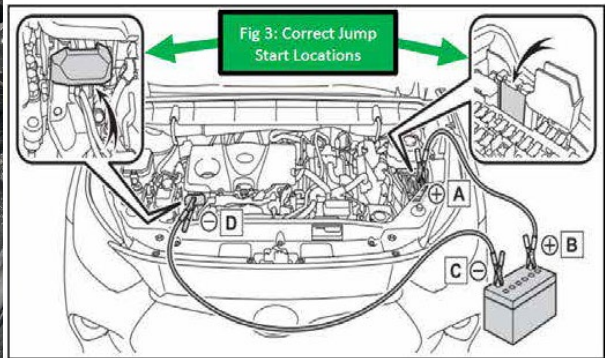
The Manufacturers recommended connection point is approx. 38" from the positive boost terminal/ECU (see Sienna Hybrid images below as an example):

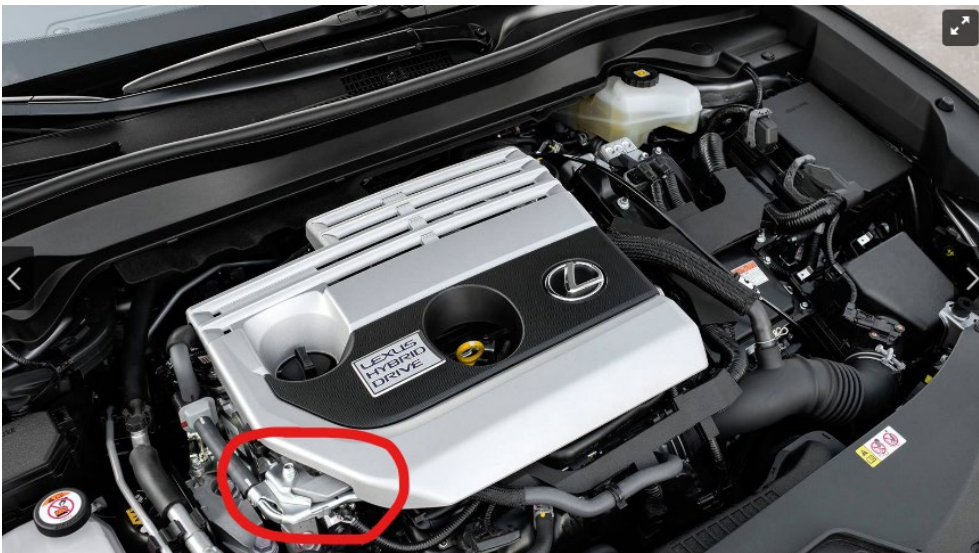
**Lexus UX Hybrid Engine: NOTE - Must remove engine cover**

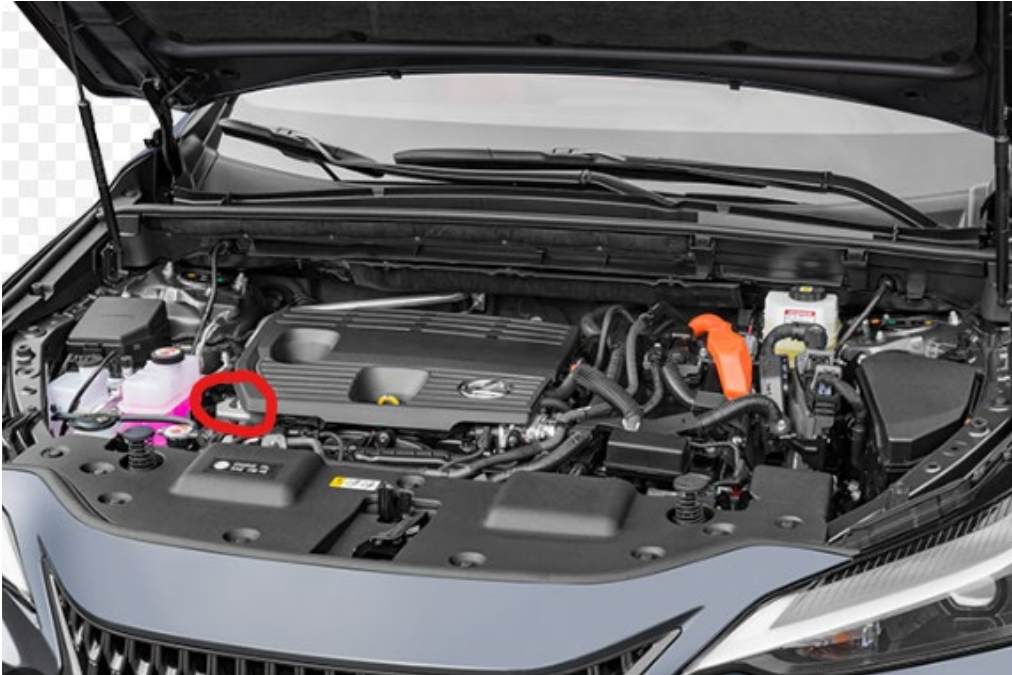
**Lexus NX Hybrid Engine:** Note - Must remove engine cover if you can't clip properly
