### Supplier Alert - Toyota and Lexus Vehicles:

ASG has been alerted regarding damage claims related to Boost services performed on Toyota & Lexus vehicles with blown damaged Engine ECU (Electronic Control Unit). The Manufacturer has identified that damage may occur as a result of connecting the negative lead too close to the ECU (not reverse connection).

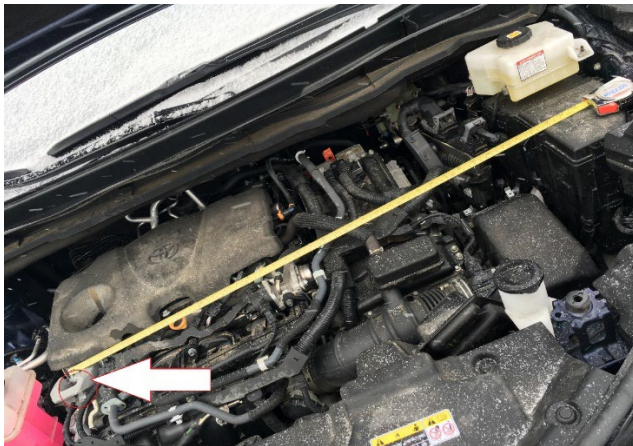
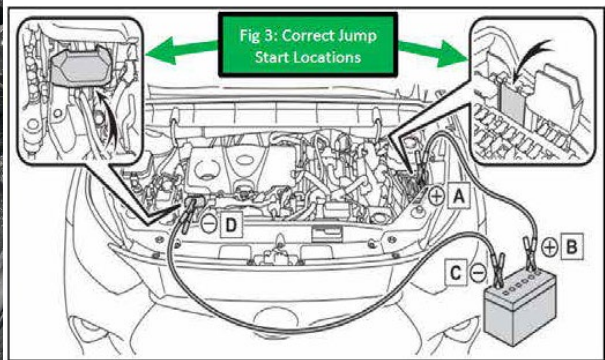
The Manufacturers recommended connection point is approx. 38" from the positive boost terminal/ECU (see Sienna Hybrid images below as an example):
