2021 Ford Mustang Mach-E

Weak Key Fob – Failure to Recognize

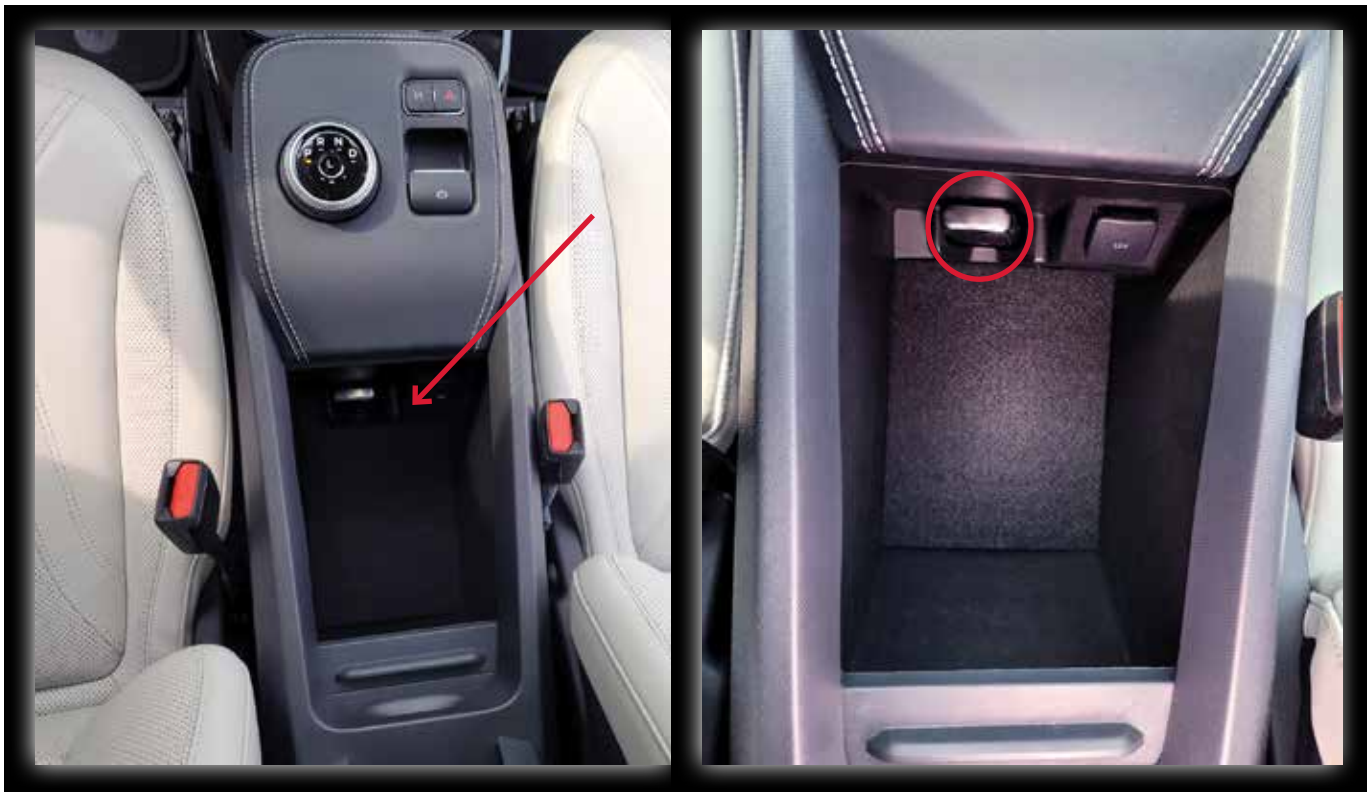
When Mach-E proximity key fob batteries become weak, the vehicle may have difficulty acknowledging its presence and not start.

The designated area in Mach-E is in on the front wall of the center console.

Placing the fob in the designated area will aid in starting the vehicle.

Immediately replace the weak key fob battery
