## 2022 Ford F-150 Lightning EV

### Weak Key Fob – Failure to Recognize

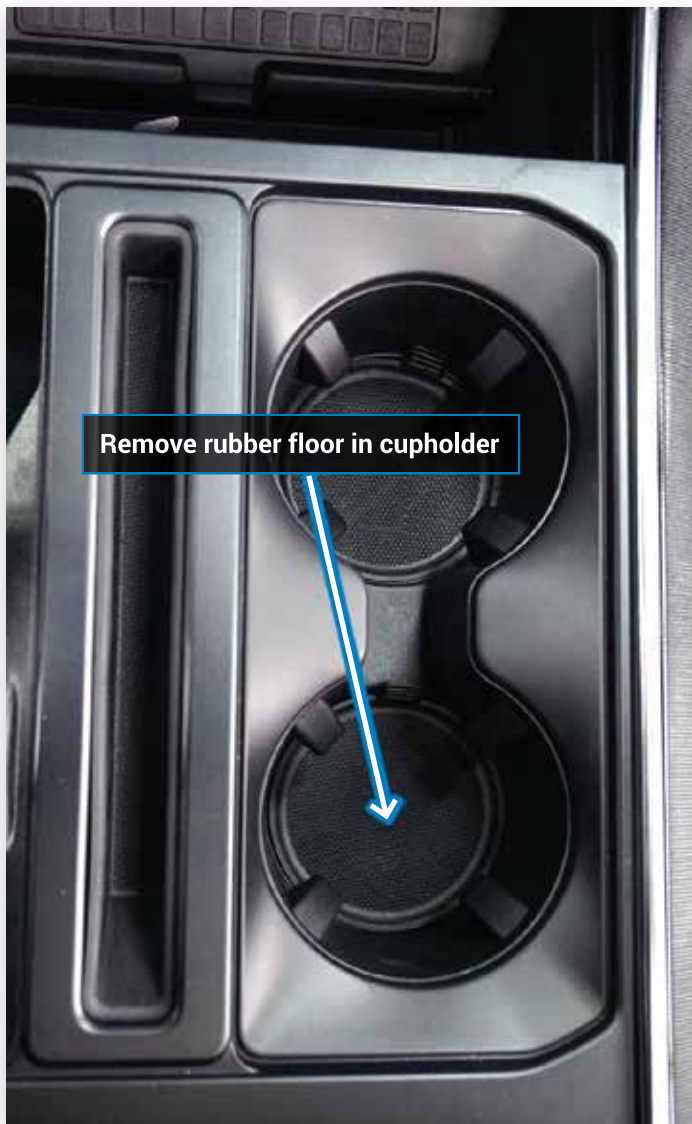
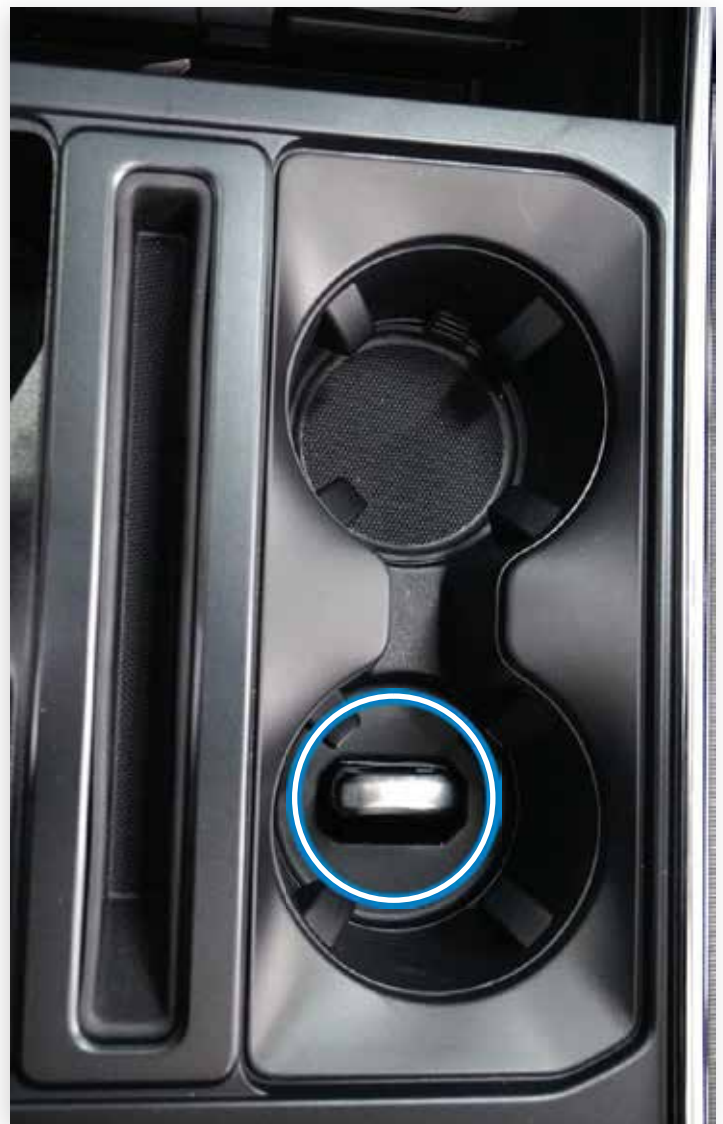
When F-150 Lightning proximity key fob batteries become weak, the vehicle may have difficulty acknowledging its presence and not start.

**The designated area in the F-150 Lightning is in the rear cup holder in the center console.**

Placing key fob in the designated area will aid in starting the vehicle.

**Immediately replace the weak key fob battery.**
